Bulletin No.: PIP5822

PIP5822 Intermittent Extended Crank or Intermittent Crank No Start and DTC P0341 Set

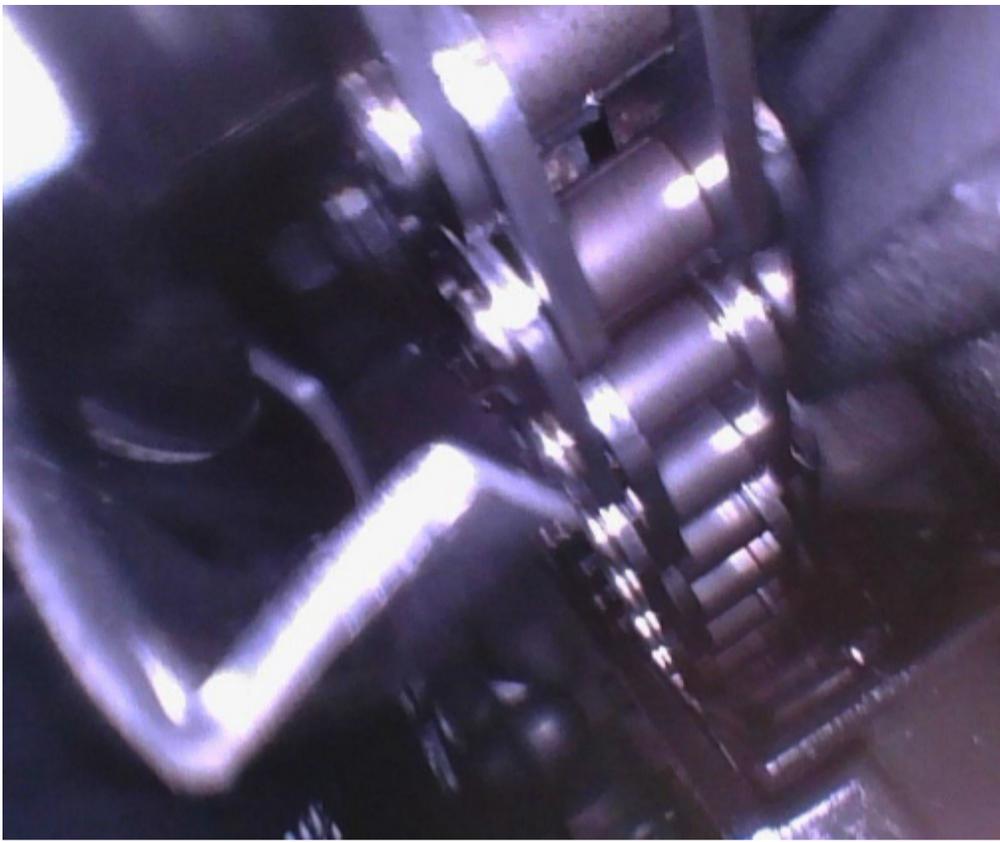
Involved Region or Country:	North America
Condition:	Some customers may experience an intermittent extended crank or intermittent crank/no start. The technician may find DTC P0341 set with the MIL illuminated. The vehicle will crank for 15 seconds until it times out but will start on the second attempt. The vehicle's Stop/Start system is not affected by this condition.
Cause:	This may be due to a corrupt signal from the Camshaft Position Sensor to the ECM

Bent cam exciter wheel contacting the timing chain

Carefully remove the camshaft position sensor and use a borescope to inspect the camshaft position sensor exciter wheel for making contact with the timing chain. If the camshaft position sensor exciter wheel is contacting the timing chain, replace the exciter wheel.
